MARINE INVESTIGATION REPORT

M01W0253

FOUNDERING

SMALL FISHING VESSEL *KELLA-LEE*

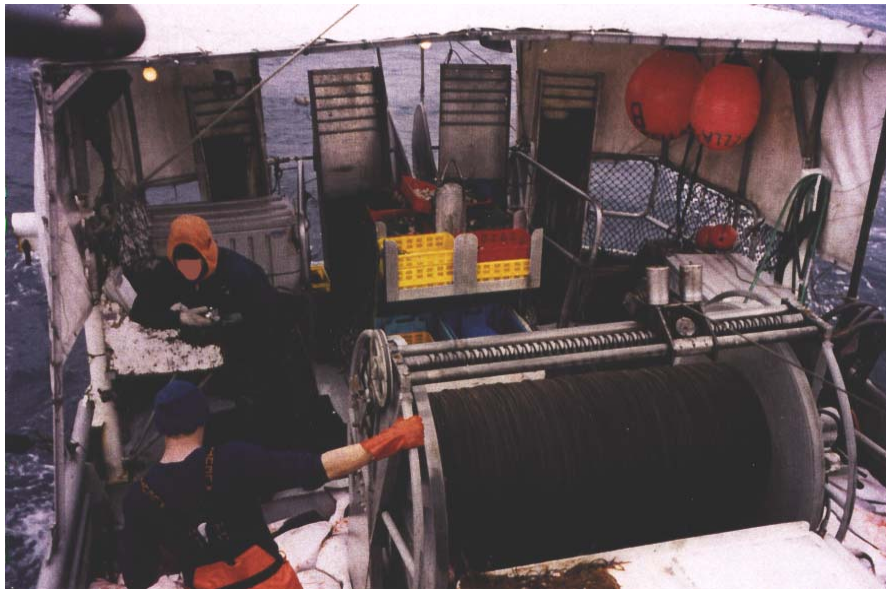
The *Kella-Lee* - after deck looking aft
